Making Sanitation Your New Year's Resolution

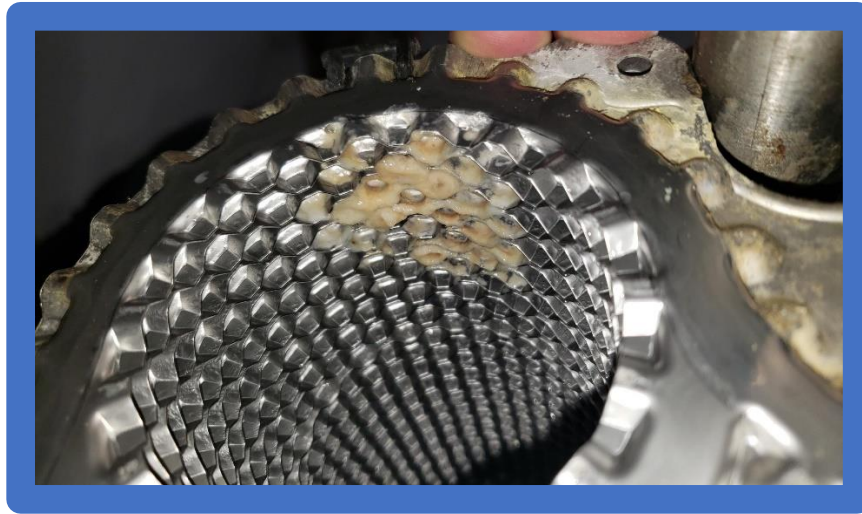
We kept at this and eventually, we found the most impressive biofilm (see photo above). This beauty was located in the upper bulk section just past the transition point where the product started to move down the plates. We collected many samples and found the predominant organism involved in the biofilm to be *Leuconostoc lactis*. This psychrotrophic lactic acid bacteria and was causing premature spoilage as reported by customer complaints. The plate cooler was thoroughly cleaned, reassembled, and a full CIP was performed. Milk samples were collected, and we confirmed that removal of this biofilm solved the high SPC problem.

We rely and (blindly) trust the CIP procedure to “do its job” for complex pieces of equipment and focus manual cleaning and sanitation efforts on the equipment that don't have a CIP option. Fortunately, this approach works most of the time. However, the efficacy of CIP in heat exchangers is highly dependent on having nearly perfect flow in every plate and every exchange zone in the system. A flow rate change or a small clog/impediment could result in an area of the machine not being effectively cleaned. A crack in a plate could lead to product contamination with a cooling fluid potentially introducing chemical (e.g., glycol) or microbial (e.g., contaminated water) hazards. Small, thin pieces of debris can get stuck between plates and the continuous flow of product erode the surface of the plates. There is no easy way to find these problems unless the equipment is disassembled.

Dismantling, cleaning, and repairing equipment is never convenient. Taking apart plate coolers (or full HTST pasteurizers) is big job for a processing system of any size and scale. Even large milk processing facilities only perform PEC on their pasteurizer on an annual basis – often after the eggnog season (nutmeg particles are hard on gaskets and surfaces). As innovation in dairy products increases and/or dairy processors co-manufacture non-dairy beverages, it is important to consider how particulates may damage your equipment and how that should influence your PEC schedule.
